An inspection was conducted at the Finley Valley/City of Ozark public water system by Missouri Department of Natural Resources (department) staff pursuant to Safe Drinking Water Law on November 19, 2015, as described in the enclosed report.

**Missouri Department of Natural Resources**  
**Southwest Regional Office/Public Drinking Water Branch**  
**Report of Inspection**  
**Finley Valley/City of Ozark**  
**Christian County, Missouri**  
**Public Water System ID Number MO5036273**  
**December 9, 2015**

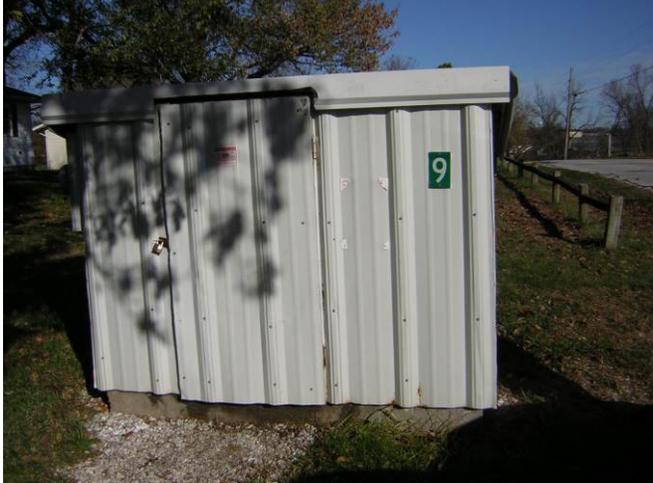
<b>PHOTOGRAPH# 1</b> <b>DATE TAKEN:</b> November 19, 2015 <b>BY:</b> Jason Wolf <b>DESCRIPTION:</b> Well #9 wellhouse containing the wellhead and chlorination system.

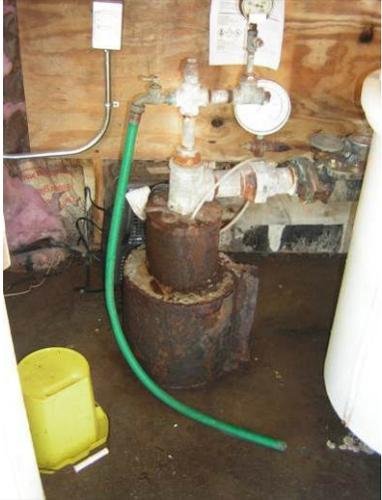
Upon arriving at Well #9, Mr. Robison unlocked the wellhouse. I noticed that the casing and surface casing is corroded. I then saw that the chlorine tank was not sealed or vented to the outside. An observable check valve is not provided for Well #9, although a check valve is provided on underground piping before distribution. After viewing Well #9, we headed to Well#10. Upon removing the insulation around the well, I noticed that the casing for Well #10 is corroded. After viewing the wellhead we entered a building to the east of the well which houses the master meter, check valve, chlorine injection, a telephone connection for automatic control of the wells, and an interconnection with Well #9.

1. The well casing was not protected against physical damage at both wells (photos 2 and 5).

<b>PHOTOGRAPH# 2</b> <b>DATE TAKEN:</b> November 19, 2015 <b>BY:</b> Jason Wolf <b>DESCRIPTION:</b> Well #9 with corroded casing.

The well casing and all exposed piping should be protected against deterioration, physical damage, and freezing. Paint the exterior of the well casing to protect it from corrosion.

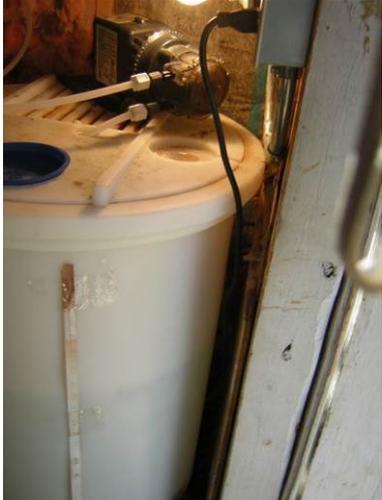
2. The chlorine solution tanks are not vented to the outside at both wells (photograph 3).

The chlorine feed and storage system is a critical component that ensures the quality of water served to the public. However, chlorine gas is a strong oxidant that will contribute to the oxidation (corrosion) of unpainted steel surfaces. To protect these steel surfaces, a coat of paint should be applied. In addition, the chlorine solution tank should be designed and constructed to be sealed and vented to the outside.

<b>PHOTOGRAPH# 3</b> <b>DATE TAKEN:</b> November 19, 2015 <b>BY:</b> Jason Wolf <b>DESCRIPTION:</b> Chlorine solution tank at Well #9. The tank is not sealed and vented to the outside.

Seal the chlorine solution tanks and vent tanks to the outside using the same flexible poly tubing used for the chlorine feeder line. The vent line should be protected by 18 gauge mesh to prevent plugging by insect activity.

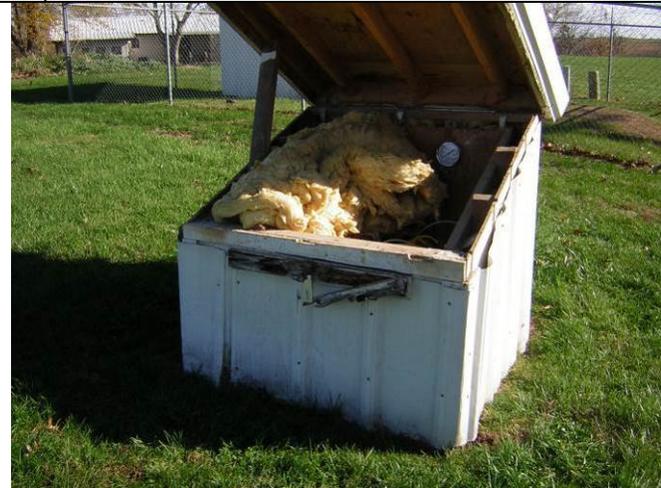
<b>PHOTOGRAPH# 4</b> <b>DATE TAKEN:</b> November 19, 2015 <b>BY:</b> Jason Wolf <b>DESCRIPTION:</b> Doghouse for Well #10.

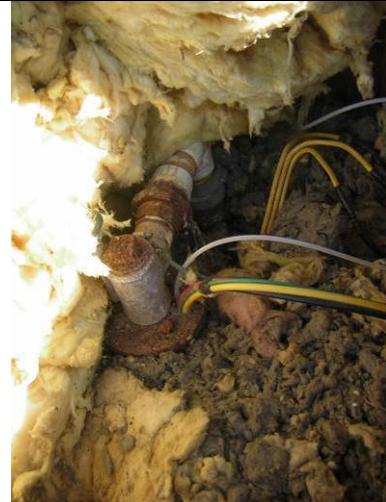
<b>PHOTOGRAPH# 5</b> <b>DATE TAKEN:</b> November 19, 2015 <b>BY:</b> Jason Wolf <b>DESCRIPTION:</b> Well #10 with electrical wires and drawdown tube.

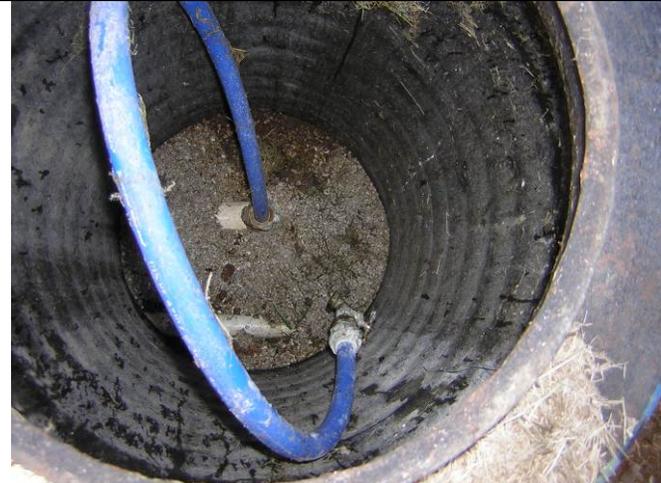
The system inspected the storage tank, maintained separate water use and loss records from the City of Ozark, and installed a raw water tap on Well #10 (photograph 6) since the last inspection on September 12, 2012.

<b>PHOTOGRAPH# 6</b> <b>DATE TAKEN:</b> November 19, 2015 <b>BY:</b> Jason Wolf <b>DESCRIPTION:</b> Raw water sample tap immediately east of the doghouse for Well #10.
